APOLLO PROGRAM

FINAL FLIGHT EVALUATION REPORT

APOLLO 7 MISSION

FEBRUARY 1969

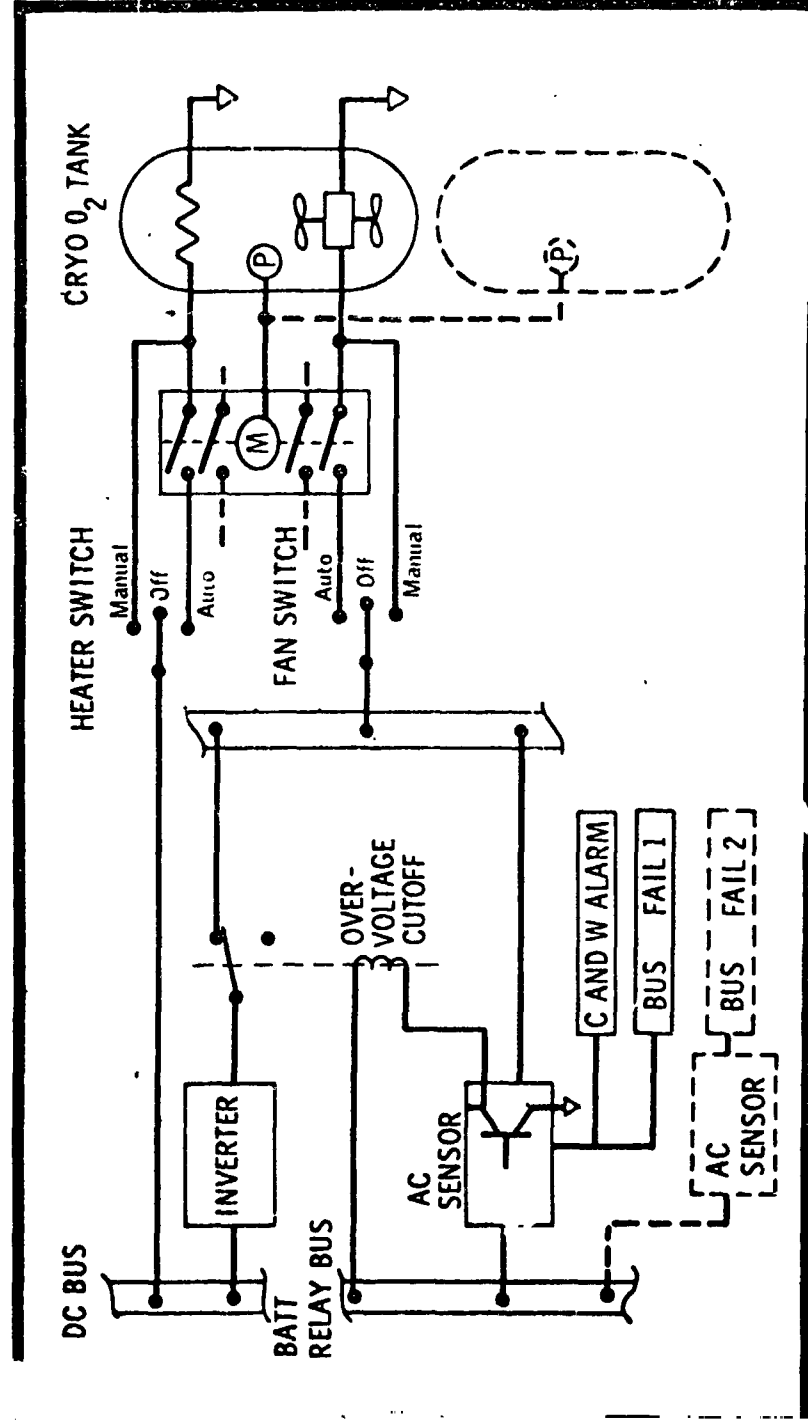
FIGURE 2.1-1-1 AC CIRCUIT FOR CRYO TANKS

NO. 2.1.1	TITLE: MOMENTARY LOSS OF AC BUSES	MISSION: APOLLO 7
SYSTEM: CSM		EVENT TIME: ORBIT
SUBSYSTEM: ELECTRIC POWER SYSTEM		
PROBLEM:	<p>AC BUS 1 DROPPED OUT AT 21:48 AND 57:00 GET. BOTH AC BUS 1 AND AC BUS 2 DROPPED OUT AT 61:15. IN EACH CASE, THE BUSES OPERATED NORMALLY AFTER BEING RESET. THE CAUSE WAS IDENTIFIED AS AN OVERVOLTAGE TRANSIENT WHICH OCCURS WHEN THE OXYGEN CRYOGENIC TANK FANS AND HEATERS CYCLE OFF IN THE AUTOMATIC MODE. AFTER A PROCEDURAL CHANGE WAS MADE TO PREVENT THE FANS IN BOTH TANKS FROM CYCLING OFF SIMULTANEOUSLY, THE PROBLEM DID NOT RECUR FOR THE REMAINING 200 HOURS OF FLIGHT.</p>	
ACTION:	<p>POST FLIGHT TESTS CONFIRM THAT THE CAUSE IS ASSOCIATED WITH ARCING OF THE MOTOR OPERATED SWITCH WHICH AUTOMATICALLY CONTROLS THE FANS AND HEATERS IN THE OXYGEN CRYOGENIC TANKS. THE MOTOR SWITCH IS ENVIRONMENTALLY SEALED RATHER THAN HERMETICALLY SEALED, THEREBY EXPOSING THE SWITCH CAVITY TO PRESSURES WHICH SUPPORT ERRATIC CORONA ARCING OF THE AC CONTACTS WHEN THE CONTROLS ARE OPENED TO TURN OFF FAN POWER. CORRECTIVE ACTION WILL BE A PROCEDURES CHANGE WHEREBY THE CRYO FANS WILL BE OPERATED MANUALLY. NO HARDWARE CHANGE WILL BE MADE.</p>

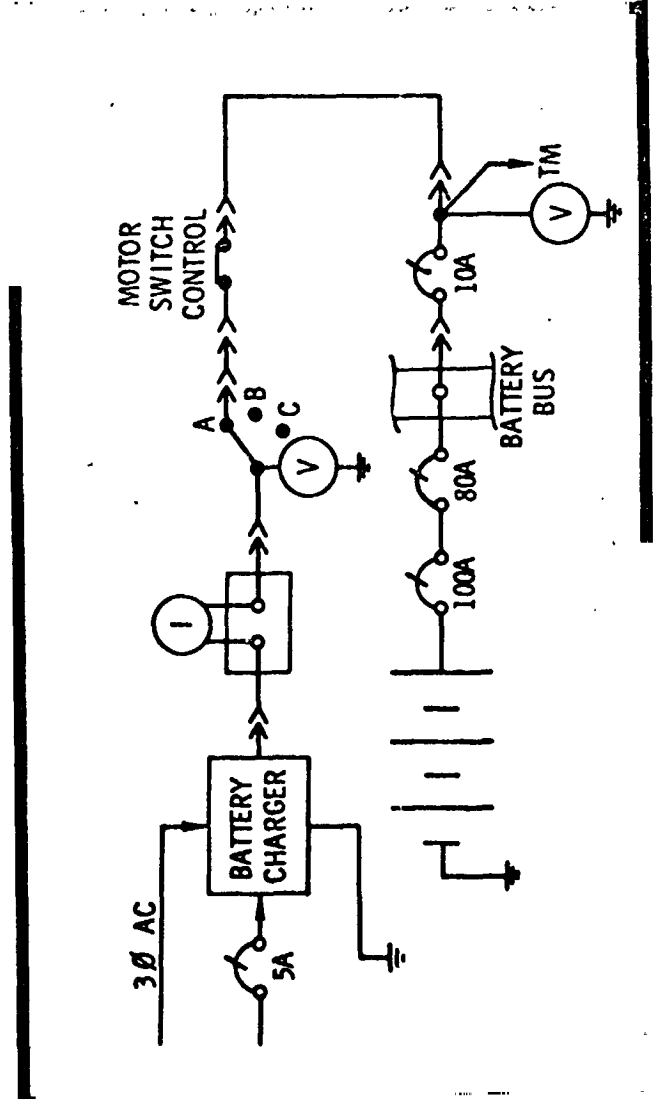
FIGURE 2.1-3 BATTERY CHARGING CIRCUIT

NO. 2.1.1.2	TITLE: LOW CHARGE RATE ON BATTERIES A AND B SYSTEM: CM SUBSYSTEM: ELECTRIC POWER SYSTEM	MISSION: APOLLO 7	EVENT TIME: ORBIT
PROBLEM: THE INFLIGHT CHARGES ON ENTRY BATTERIES A AND B RETURNED 50 TO 75 PERCENT LESS ENERGY TO THE BATTERIES THAN EXPECTED. THE RESISTANCE OF THE SPACECRAFT CHARGING CIRCUIT GREATLY AFFECTS THE ENERGY RETURNED TO THE BATTERIES, IN THAT THE CHARGING POTENTIAL IS REDUCED BY THE LINE LOSSES IN THE CIRCUIT. THIS RESISTANCE WAS DETERMINED ANALYTICALLY ON APOLLO 7. PREFLIGHT TESTS ON THE BATTERY CHARGING CIRCUITS WERE CONDUCTED ON A FUNCTIONAL BASIS, AND AN INTEGRATION TO DETERMINE ENERGY RETURNED WAS NOT ACCOMPLISHED.		ACTION: PREFLIGHT, INFLIGHT, AND POSTFLIGHT TESTS ON THE SPACECRAFT AND GROUND TESTS DURING THE MISSION, ALL CONDUCTED USING THE ACTUAL SPACECRAFT CIRCUIT RESISTANCES, SHOWED THE SAME CHARACTERISTICS AND RESULTED IN A LOW ENERGY RETURN TO THE BATTERY. ON FUTURE SPACECRAFT, INDIVIDUAL CHARGER CHARACTERISTICS WITH THE ASSOCIATED LINE DROP WILL BE CHECKED FOR SATISFACTORY BATTERY CHARGING.

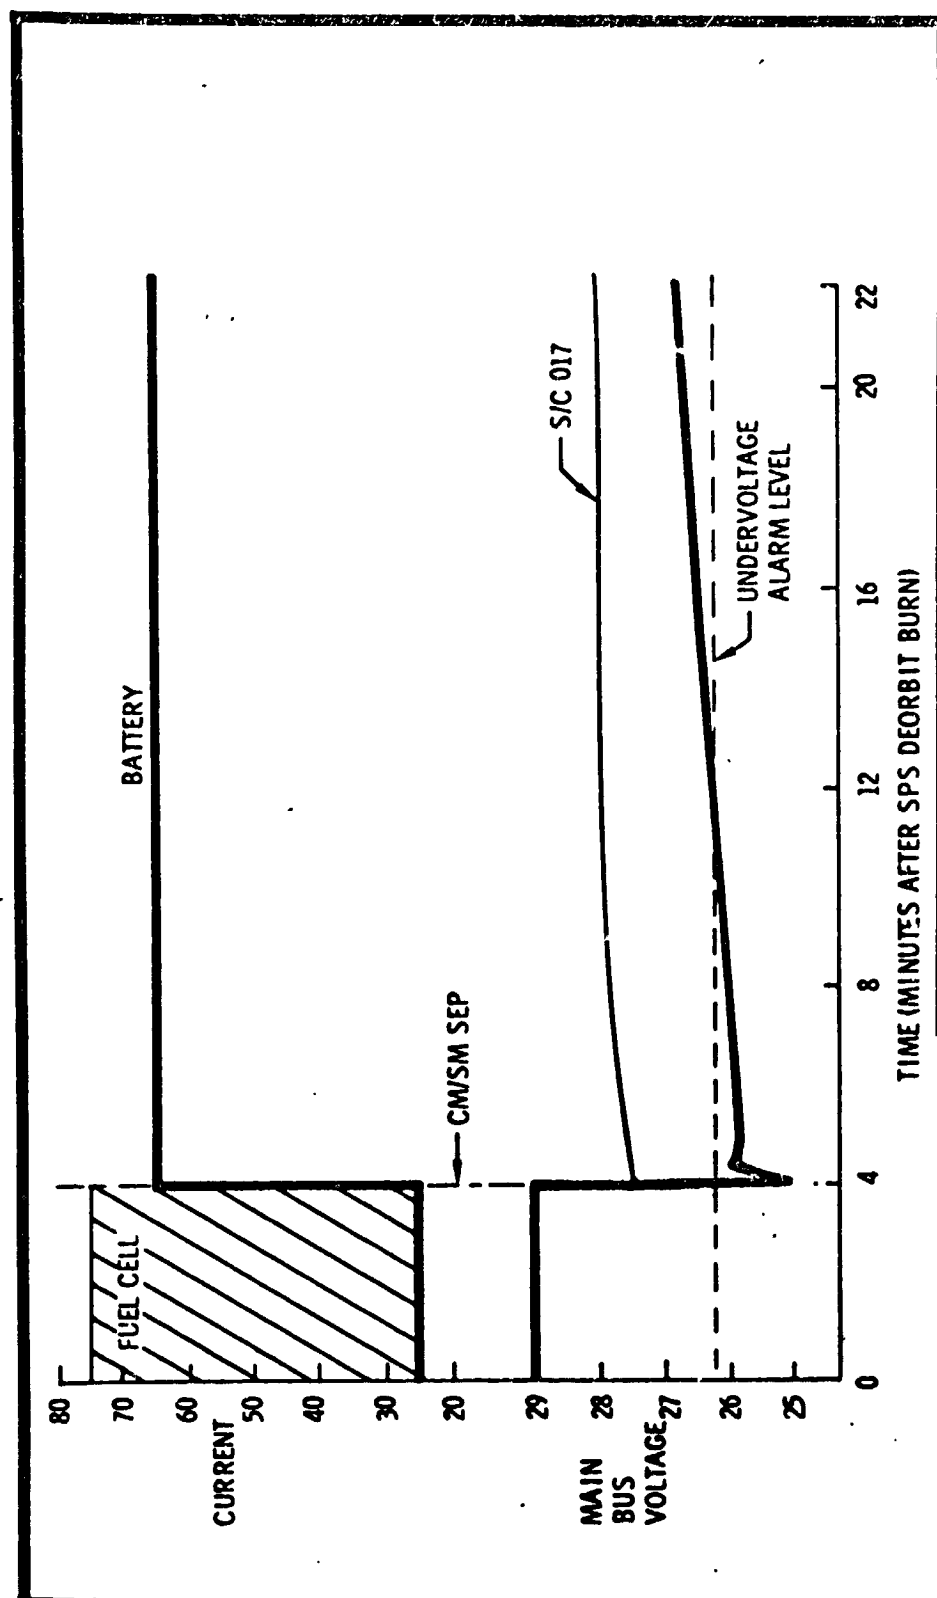
FIGURE 2.1-5 MAIN BUS UNDERVOLTAGE

NO. 2.1.1.3	TITLE: UNDERVOLTAGE INDICATION ON DC BUSES A AND B	MISSION: APOLLO 7
SYSTEM:	COMMAND MODULE	EVENT TIME: CM/SM SEPARATION
SUBSYSTEM:	ELECTRICAL	
PROBLEM:	<p>AT CM/SM SEPARATION THE MAIN DC BUS VOLTAGE FELL BELOW THE UNDERVOLTAGE ALARM LEVEL (25 VOLTS) AND THEN ROSE SLOWLY GOING ABOVE THE ALARM LEVEL (26.2V) IN ABOUT 5 MINUTES AND TO 27.0 VOLTS IN 20 MINUTES. THIS LOW VOLTAGE CONDITION RESULTED FROM THE MID RANGE STATE OF CHARGE, LOW TEMPERATURE AND THE DISPLACEMENT OF ELETROLYTE FROM CONTACT WITH THE PLATES BECAUSE OF THE ZERO-G ENVIRONMENT.</p>	
ACTION:	<p>FOR APOLLO 8, THE BATTERIES WERE TO BE WARMED PRIOR TO COMMAND MODULE/SERVICE MODULE SEPARATION BY PLACING THEM ON THE MAIN BUSES AND/OR BY SWITCHING INVERTER 3 ON THE AC BUS IN PLACE OF INVERTER 1 TO PROVIDE RADIANT HEATING. FUEL CELL 2 WAS REMOVED FROM THE BUSES PRIOR TO SEPARATION TO LESSEN THE TRANSIENT LOAD. FOR SUBSEQUENT MISSIONS, THE BATTERY SEPARATOR MATERIAL WILL BE CHANGED TO ABSORPTIVE CELLOPHANE MATERIAL TO REDUCE THE EFFECTS OF ZERO-G.</p>

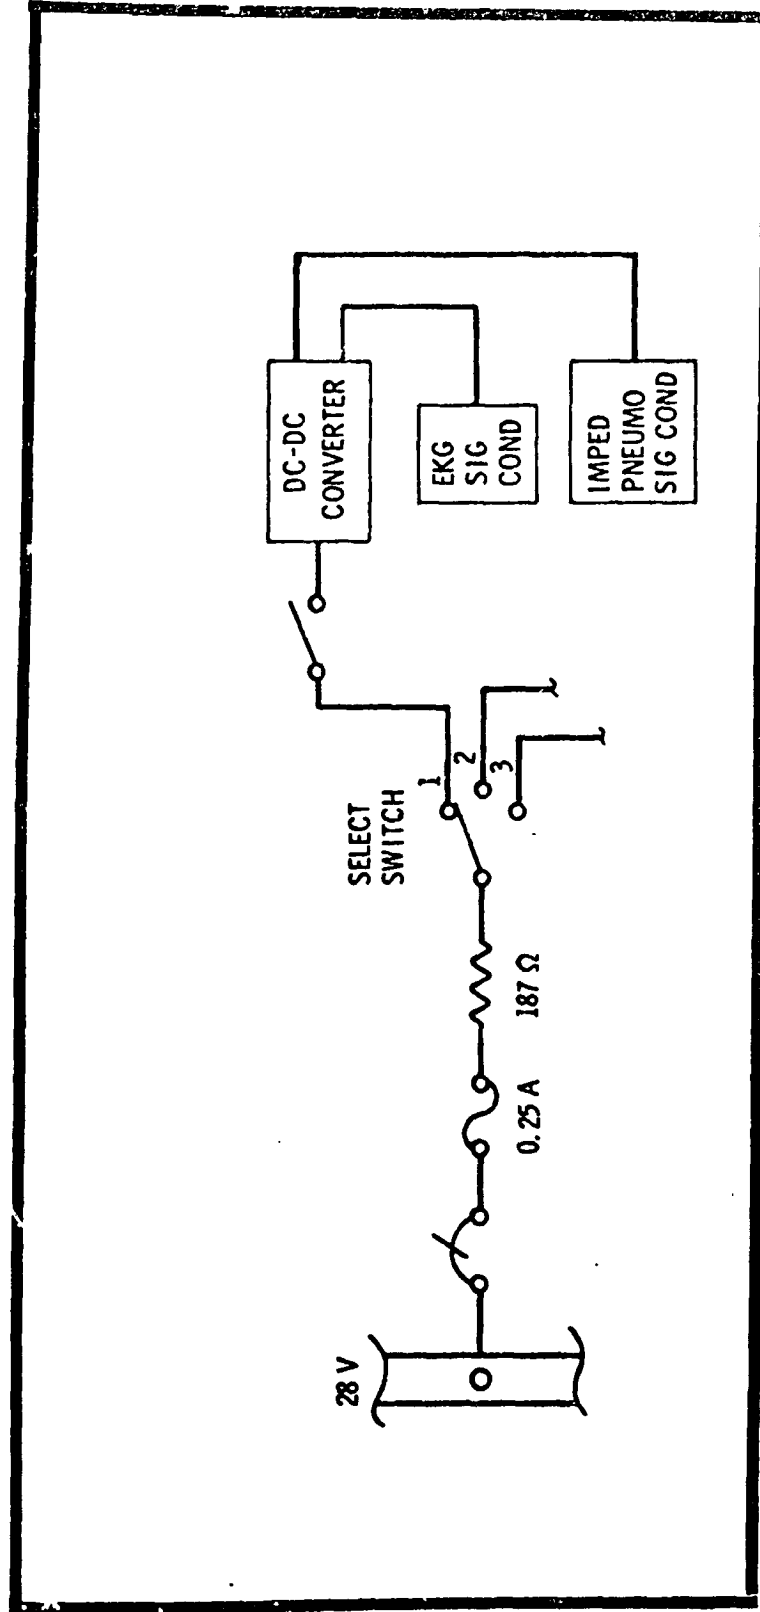
FIGURE 2.1-6

NO. 2.1.6	TITLE: BIOMEDICAL INSTRUMENTATION MISSION: APOLLO 7 EVENT TIME: 16:23 GET
SYSTEM: BIO-MED SUBSYSTEM: ASTRONAUT HARNESS	<p>PROBLEM: TWO DISCREPANCIES WERE ENCOUNTERED WITH THE BIOMEDICAL INSTRUMENTATION EQUIPMENT. FIRST, A WIRE WAS BROKEN AT THE CONNECTOR TO THE EKG SIGNAL CONDITIONER ON EACH OF TWO HARNESSES. IN ADDITION, THE PIN CONNECTORS TO THE SENSORS PERIODICALLY BECAME DISCONNECTED. SECOND, THE DC-DC CONVERTER USED TO SUPPLY POWER TO THE BIOMEDICAL SIGNAL CONDITIONER ON THE SUIT HARNESS, WAS REPORTED TO BE PHYSICALLY HOT.</p> <p>POSTFLIGHT INSPECTION REVEALED BROKEN SENSOR WIRES AND A GREEN FOREIGN SUBSTANCE IN THE ELECTRICAL CONNECTIONS ON EACH END OF THE CONTROL HEAD OF THE BIOMEDICAL/ COMMUNICATIONS CABLING. DC-DC CONVERTER NORMAL OPERATION APPROXIMATELY 108°F WITH LOCAL HOT SPOTS OF 116°F.</p> <p>ACTION:</p> <p>CORRECTIVE ACTIONS TAKEN TO MINIMIZE WIRE BREAKAGE INVOLVE</p> <ol style="list-style-type: none"> (1) REPLACEMENT OF TEFLON WIRE WITH THE MORE FLEXIBLE POLYVINYL CHLORIDE WIRE. (2) REPLACEMENT OF HARD POTTING WITH SOFT POTTING MATERIAL. (3) DELETION OF IN-LINE CONNECTORS. <p>COMPONENT, SYSTEM AND COMMAND MODULE LEVEL TESTING HAV: BEEN COMPLETED AND NO MALFUNCTIONS WERE FOUND.</p> <p>TESTS OF THE GREEN SUBSTANCE ATTRIBUTE IT TO CORROSION FROM SEA WATER.</p> <p>THE APOLLO 8 CREW HAVE PARTICIPATED IN DEMONSTRATIONS WITH DC-DC CONVERTER TEMPERATURES OF 120° AND 135°F. CREW WILL INSPECT ELECTRICAL CONNECTORS FOR CLEANLINESS PRIOR TO MATING. THE UNIT WILL BE REMOVED, AS ON APOLLO 7, IF TEMPERATURES BECOME UNBEARABLE.</p>

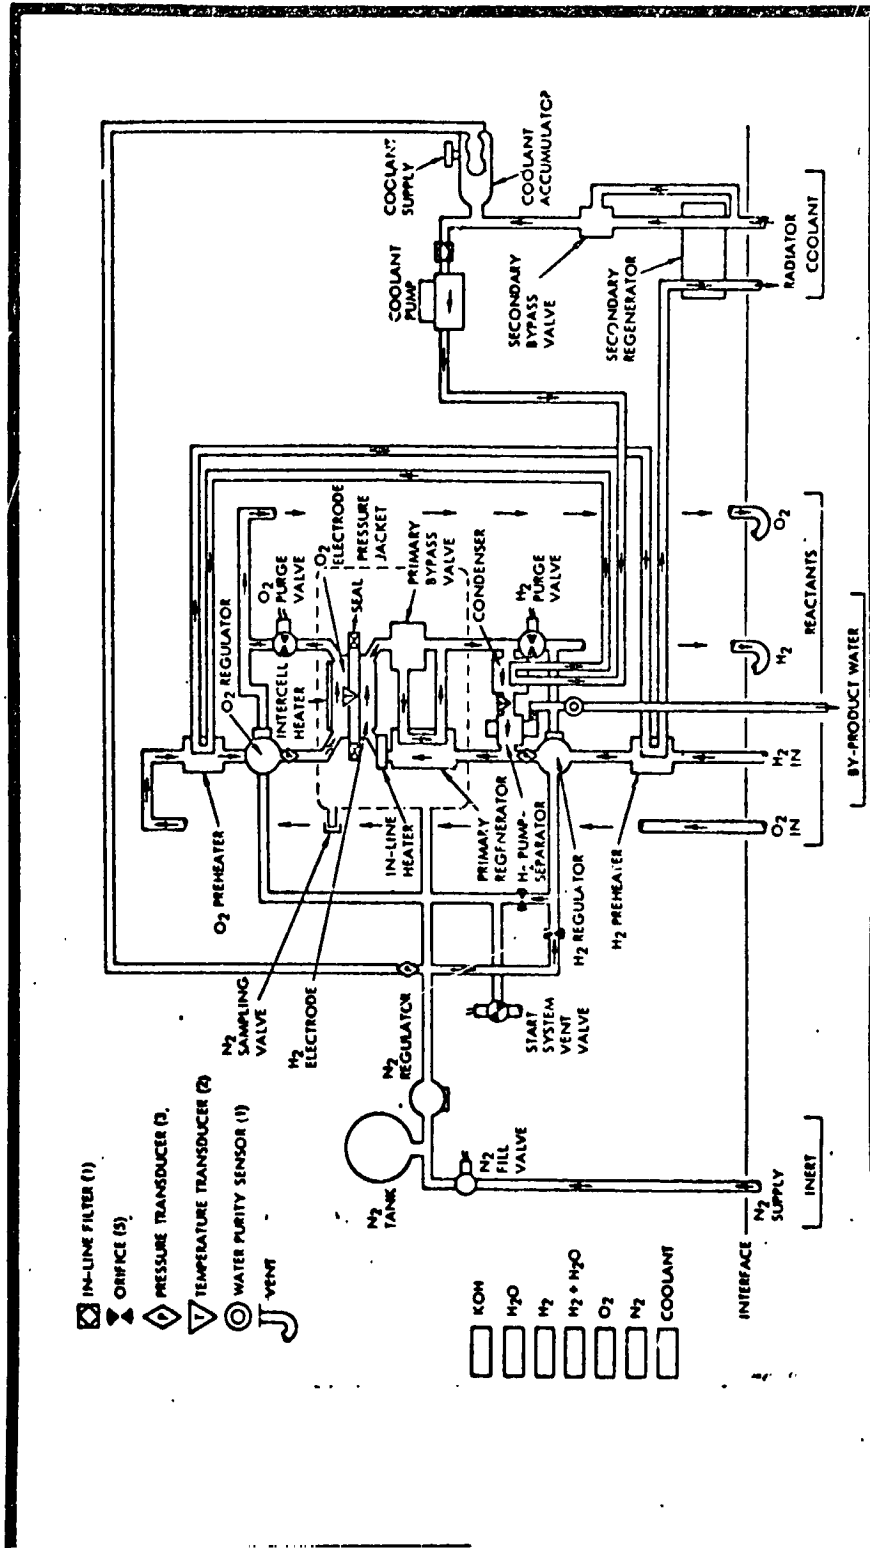
FIGURE 2.1-7 APOLLO FUEL CELL POWER PLANT MODEL PC3A-2 FLOW SCHEMATIC

NO. 2.1.1.7	TITLE: FUEL CELL EXIT TEMPERATURE INCREASE	SYSTEM: CM	MISSION: APOLLO 7
SUBSYSTEM: ELECTRICAL POWER SYSTEM	EVENT TIME: 164:50		
<p>PROBLEM: PRIOR TO THE FIFTH SERVICE PROPULSION MANEUVER, THE CONDENSER EXIT TEMPERATURE OF FUEL CELL 2 INCREASED TO 180°F (NOMINAL IS 155° TO 165°F). THE ELECTRICAL LOAD WAS REMOVED FROM THE FUEL CELL FOR APPROXIMATELY 54 MINUTES TO PERMIT COOLING PRIOR TO THE SERVICE PROPULSION MANEUVER. DURING THIS PERIOD, THE FUEL CELL 1 CONDENSER EXIT TEMPERATURE INCREASED TO 175°F; HOWEVER, THE TEMPERATURE RETURNED TO THE NORMAL OPERATING LEVEL AFTER FUEL CELL 2 WAS RETURNED TO THE BUS. FUEL CELL 1 OPERATED SATISFACTORILY FOR THE REMAINDER OF THE MISSION.</p> <p>FOUR DAYS LATER, THE ELECTRICAL LOAD WAS AGAIN REMOVED FROM FUEL CELL 2 FOR A SHORT PERIOD OF TIME TO INSURE PROPER PERFORMANCE DURING THE DEORBIT MANEUVER. AFTER THE FIFTH SERVICE PROPULSION MANEUVER, EVERY TIME THE FUEL CELL LOADS WERE INCREASED, THE FUEL CELL 2 EXIT TEMPERATURE INCREASED TO A LEVEL BETWEEN 180° and 190°F.</p> <p>FLIGHT DATA INDICATE THAT THE ABNORMAL OPERATION WAS CAUSED BY MALFUNCTIONS IN THE RESPECTIVE SECONDARY BYPASS VALVES. AFTER THE FLIGHT, SIMILAR ERRATIC OPERATION OF THE SHUTTLE VALVE WERE DEMONSTRATED WITH CONTAMINANTS INTENTIONALLY INTRODUCED INTO THE SYSTEM.</p>

<p>ACTION: ON APOLLO 8, THE RADIATOR HALF OF THE COOLING SYSTEM WAS DRAINED, FLUSHED, AND RESERVICED AS A PRECAUTIONARY MEASURE. ADDITIONALLY, STUDIES ARE BEING MADE CONCERNING THE NECESSITY OF ADDING A FILTER UPSTREAM OF THE BYPASS VALVE OR MODIFYING THE SYSTEM SUCH THAT THE VALVE IS AFFORDED BETTER PROTECTION. THE OUTCOME OF THE STUDY WILL DETERMINE WHAT CAN BE DONE PRACTICALLY TO ALLEVIATE THE CONTAMINATION PROBLEM ON SUBSEQUENT SPACECRAFT.</p>			
<p>ORGANIZATION: 5-2490</p> <p>REFERENCES: MSC 3 DAY REPORT P4 MSC 15-DAY REPORT P6 ANOMALY STATUS REPORT, 12-17-68, P7 MSC ANOMALY REPORT, NOV. 68, P-8 MSC 60 DAY REPORT 12-68, P11-9</p>		<p>RESOLUTION: CLOSED</p> <p>DATE: 1-30-69</p> <p>REV: A</p>	
			38

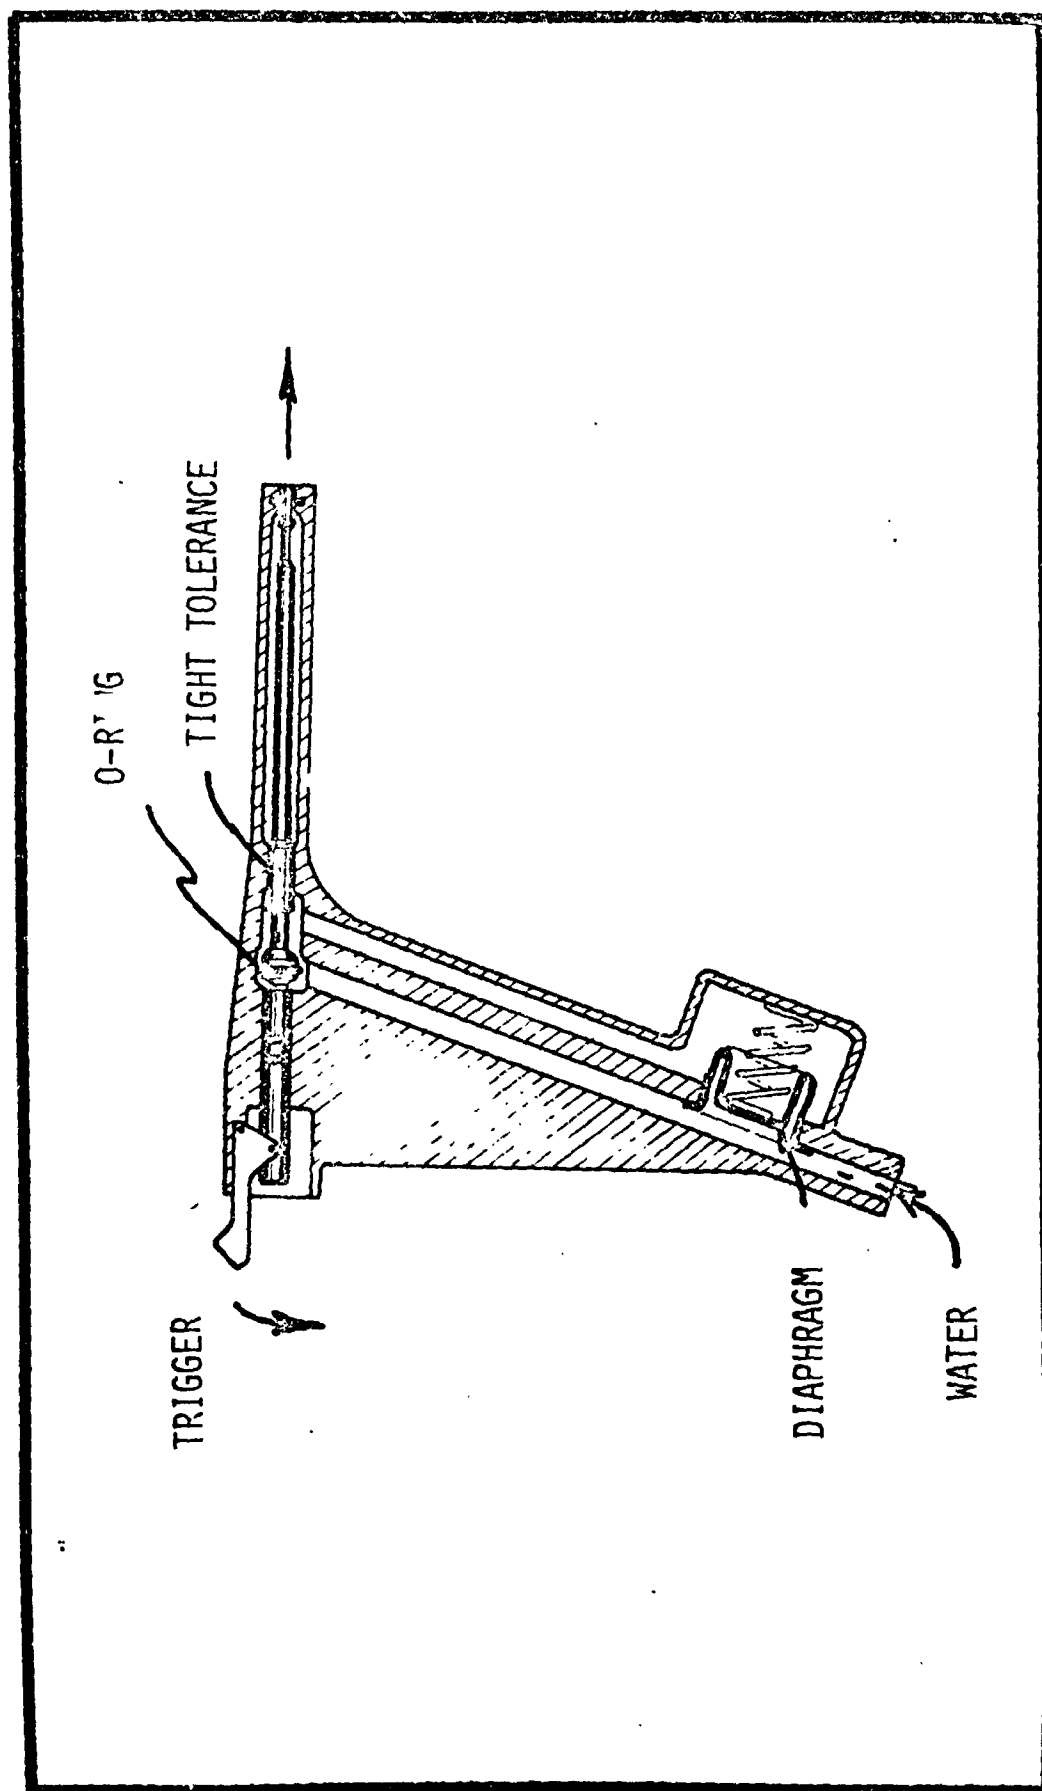
FIGURE 2.1-9 WATER GUN CUTAWAY

NO. 2.1.1.10	TITLE: WATER GUN TRIGGER	MISSION: APOLLO 7
SYSTEM: CSM		EVENT TIME: 165:31
SUBSYSTEM: WATER MANAGEMENT		
PROBLEM:	DURING THE LATER PART OF THE MISSION THE WATER GUN BECAME DIFFICULT TO OPERATE.	
ACTION:	<p>POST FLIGHT TESTING HAS SHOWN THAT THE METERING O-RING INCREASED IN OUTSIDE DIAMETER. A NEW O-RING WAS INSTALLED AND TRIGGER ACTUATING FORCES RETURNED TO NORMAL. THE NEOPRENE O-RING IS NOT COMPATIBLE WITH CHLORINE AND TENDS TO SWELL.</p> <p>NO EFFECT ON APOLLO 8. THE "O-RING" HAS BEEN REPLACED WITH ONE OF ETHYLENE PROPYLENE. THE O-RING MATERIAL WILL BE CHANGED ON ALL FUTURE MISSIONS. TESTS TO DATE INDICATE THE NEW O-RING MATERIAL IS COMPATIBLE WITH SODIUM HYPOCHLORATE. ACTIVATION FORCES WITH THE NEW O-RING ARE LESS THAN THOSE WITH THE NEOPRENE O-RING.</p>	
ORGANIZATION: 5-2490	RESOLUTION: CLOSED	DATE: 1-30-69
REFERENCES: MSC 3 DAY REPORT P-10		REV: A
SPACECRAFT SUBSYSTEM REVIEW MTG 10-29-68

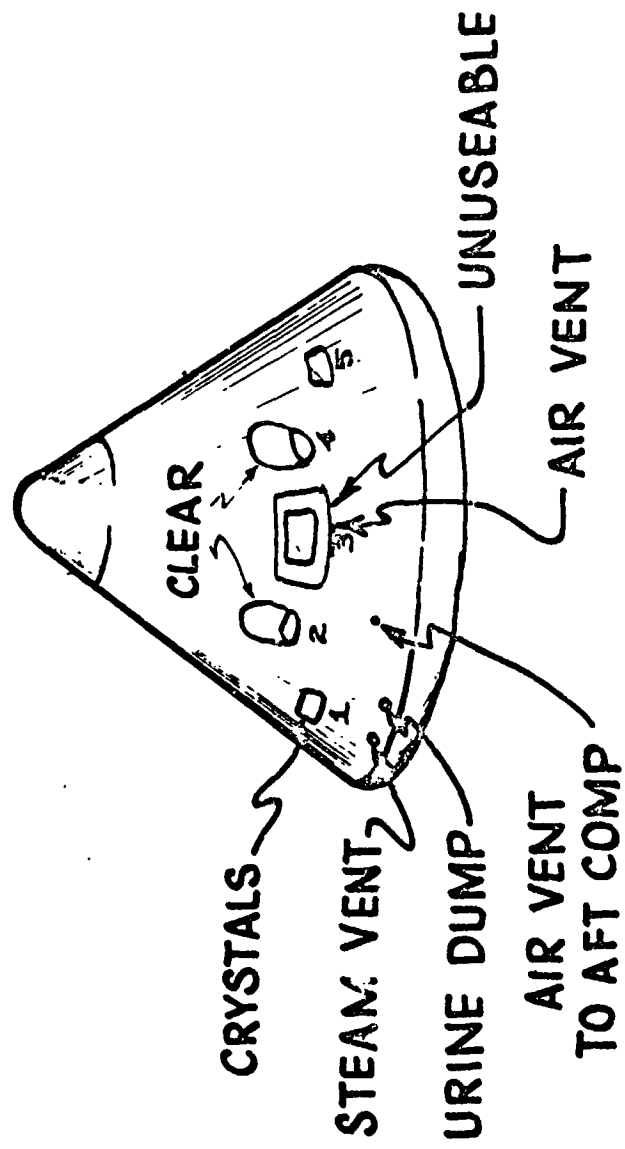
FIGURE 2.1-10 CM WINDOW ARRANGEMENT

NO. 2.1.1.5	TITLE: WINDOW CONSTRUCTIONS TO VISION	MISSION: APOLLO 7
	SYSTEM: COMMAND MODULE	EVENT TIME: 47:49 HRS GET
	SUBSYSTEM: WINDOWS	
PROBLEM:	<p>DURING FLIGHT, WINDOWS 1,3, AND 5 SHOWED SOME FOGGING OR FROSTING FROM AN OILY FILM AND/OR EXTERIOR DEPOSITS. A SMALL AMOUNT OF GRAY FILM FROM THE TOWER JETTISON MOTOR AND/OR THE SEPARATION BOLTS WAS DEPOSITED AT THE EDGES OF WINDOWS 2 AND 4 WITHOUT IMPAIRING VISIBILITY. AFTER LANDING, WHILE THE COMMAND MODULE WAS IN STABLE II POSITION, WINDOWS 1,3, AND 5 FILLED WITH WATER BETWEEN THE HEAT SHIELD AND PRESSURE VESSEL. SEA WATER REMOVED ANY EXTERIOR DEPOSITS SUCH AS THOSE RELATED TO URINE AND WASTE WATER DUMP. INSULATION FILLS OR PARTIALLY FILLS THE SPACE BETWEEN THE CREW COMPARTMENT HEAT SHIELD AND THE PRESSURE VESSEL. AROUND WINDOWS 2 AND 4, THE INSULATION IS PACKED RATHER TIGHTLY, ACCOUNTING FOR WINDOWS 2 AND 4 NOT FILLING WITH WATER. THE EDGES OF THE INSULATION AROUND EACH WINDOW OPENING ARE SEALED WITH TAPE AND RTV. THE INTERIOR ALUMINUM FRAME FOR EACH HEAT SHIELD WINDOW WAS TO HAVE BEEN COVERED WITH INSULATION MATERIAL BUT HAD PARTIALLY EXPOSED METAL.</p>

ACTION:	<p>THE OILY FILM ON THE INSIDE OF THE HEAT SHIELD WINDOWS WAS A PRODUCT OF THE OUTGASSING OF THE RTV. A TRACE OF THE OILY FILM WAS FOUND ON WINDOWS 2 AND 4, A GREATER AMOUNT ON WINDOWS 1 AND 5, AND A CONSIDERABLE AMOUNT ON WINDOW 3.</p> <p>THE ROOM-TEMPERATURE-CURED PARTS ARE TO BE REPLACED ON FUTURE SPACECRAFT BY PARTS WHICH HAVE BEEN PRE-CURED IN VACUUM AT ELEVATED TEMPERATURES (SIMILAR TO THE GEMINI MODIFICATION). THE CHANGE IS BEING VERIFIED BY GROUND TESTS AND WILL BE IMPLEMENTED ON COMMAND MODULE 104.</p>	
ORGANIZATION: REFERENCES:	<p>5-2490 SPACECRAFT SUBSYSTEMS REVIEW MTG. 10-29-68 APOLLO 8 FRR MTG., NOVEMBER 12, 1968 ANOMALY STATUS REPORT 12-17-68, P-6 MSC ANOMALY REPORT, NOV. 68, P-4 MSC 60 DAY REPORT 12-68, P.11-64</p>	
	RESOLUTION: CLOSED	DATE: 1-30-69 REV: A.
		49

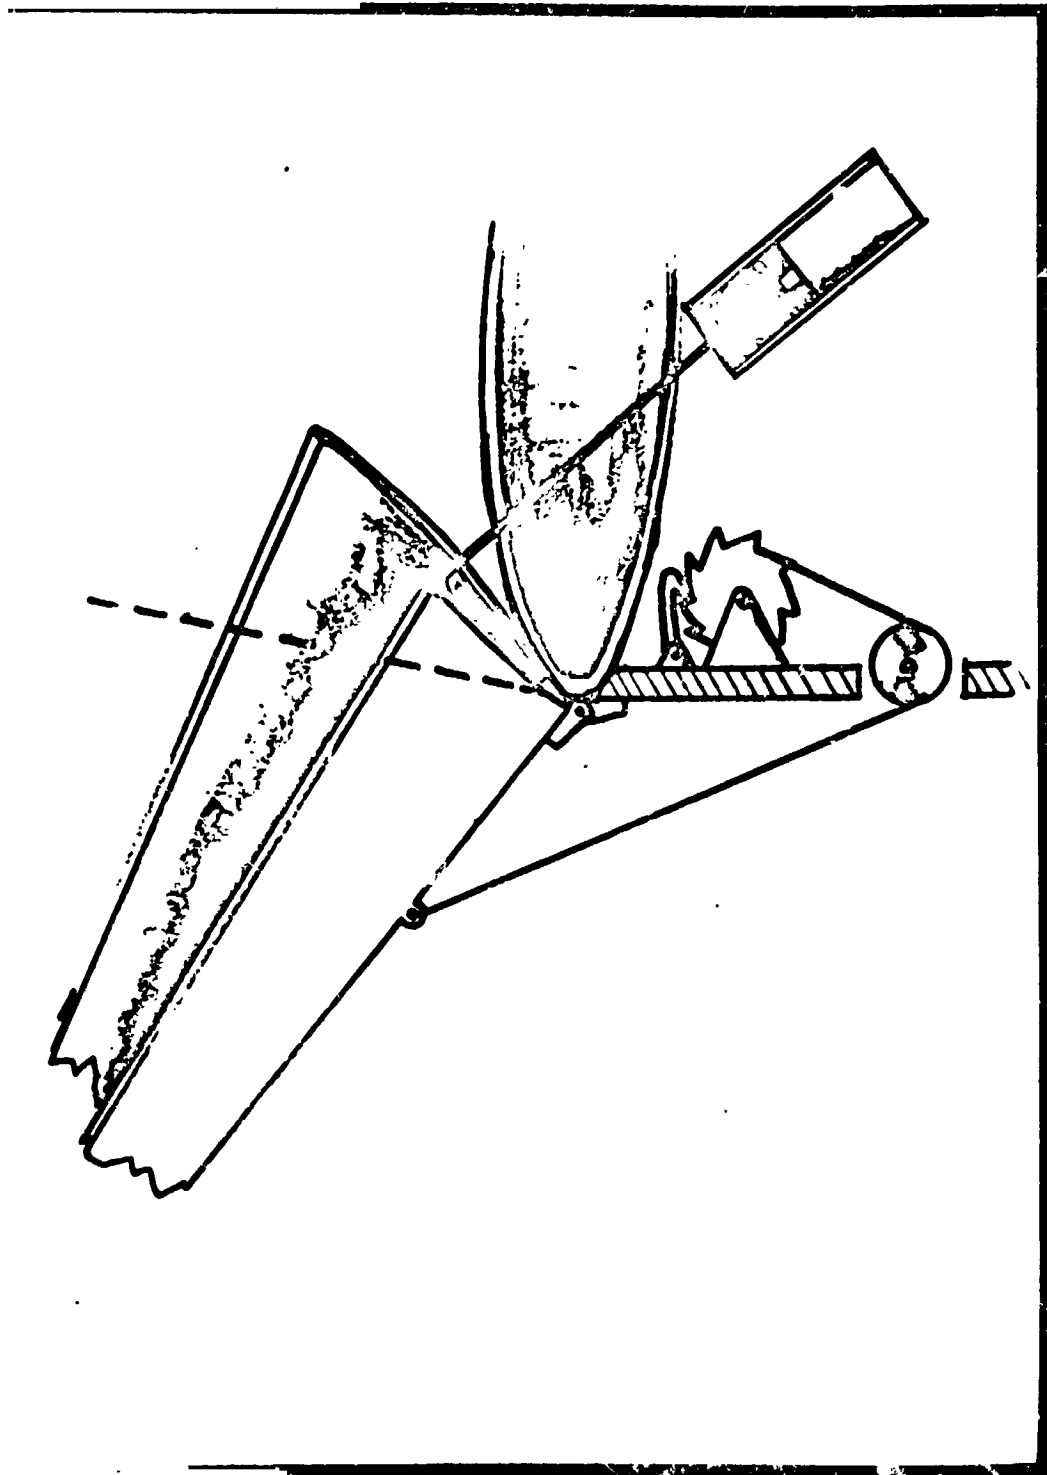
FIGURE 2.1-12 SLA PANEL EXTENDED

NO. 2.1.22	TITLE: SLA PANEL DEPLOYMENT MALFUNCTION	MISSION: APOLLO 7
SYSTEM: SLA	EVENT TIME: 2:50 GET	
SUBSYSTEM: DEPLOYMENT SYSTEM		
PROBLEM: PHOTOGRAPHS TAKEN DURING THE SECOND REVOLUTION SHOWED THAT THREE OF THE ADAPTER PANELS WERE OPENED TO ABOUT 45 DEGREES, BUT THE REMAINING PANEL (+Y) WAS OPEN ONLY ABOUT 25 DEGREES. PHOTOGRAPHS TAKEN DURING REVOLUTION 19 SHOWED ALL FOUR PANELS OPEN AT THE NORMAL ANGLE OF ABOUT 45 DEGREES. STILL PHOTOGRAPHS TAKEN DURING THE SECOND REVOLUTION SHOW THAT THE TWO ATTENUATOR CABLES ATTACHED TO THE LOWER CORNERS OF THE PANELS WERE SLACK ON THE PANEL WHICH WAS NOT FULLY DEPLOYED, INDICATING THE PANEL HAS GONE TO THE FULL-OPEN POSITION AND RETURNED TO THE OBSERVED POSITION. THE OUTSIDE RETENTION CABLE, DESIGNED TO PREVENT PANEL REBOUND AFTER OPENING, IS VISIBLE ON THREE PANELS BUT NOT ON THE +Y PANEL IN THE PHOTOGRAPH FROM REVOLUTION 2; HOWEVER, THE CABLE ON THE +Y PANEL IS VISIBLE IN THE REVOLUTION 19 PHOTOGRAPHS.

ACTION: THE ROLL RATE OF ABOUT 7 DEG/SEC DURING THE 19TH REVOLUTION WAS NOT SUFFICIENT TO COMPRESS THE HONEYCOMB IN THE ATTENUATORS (A ROLL RATE OF ABOUT 120 DEG/SEC WOULD BE REQUIRED). THEREFORE, AS INDICATED BY THE SLACK ATTENUATOR CABLES IN THE FIRST PHOTOGRAPHS, THE PANEL DID FULLY DEPLOY INITIALLY BUT THEN REBOUNDED BECAUSE THE RETENTION CABLE WAS CAUGHT IN THE CHANNEL. THE ROLL RATE WAS, HOWEVER, SUFFICIENT TO MOVE THE PANEL TO THE FULL OPEN POSITION. WHEN THE RETENTION CABLE LATER RELEASED, PRIOR TO REVOLUTION 19, THE SLACK WAS PROPERLY REELED IN, AND THE PANEL WAS THEN RETAINED OPEN.	ALL FOUR PANELS ARE TO BE JETTISONED ON FUTURE MISSIONS AND DO NOT HAVE THE RETENTION CABLE WHICH CAUSED THE PROBLEM. NO HARDWARE CHANGES ARE REQUIRED.	
ORGANIZATION: 5-2490 REFERENCES: MSC 24 HR REPORT. P3 SPACECRAFT SUBSYSTEMS REVIEW MTG, 10-29-68 MSC ANOMALY STATUS REPORT, 11-19-68 MSC ANOMALY AND FAILURE LISTING REPORT, NOV. 68 MSC 60 DAY REPORT, 12-68, P11-5	RESOLUTION: CLOSED	DATE: 1-30-69 REV: A
